# Manhole Inspection Summary

Manhole # S690\_\_017MH

Insp Date: **2/1/08 1:44 PM**

**Location** Address: **6608 Gary Ave.**

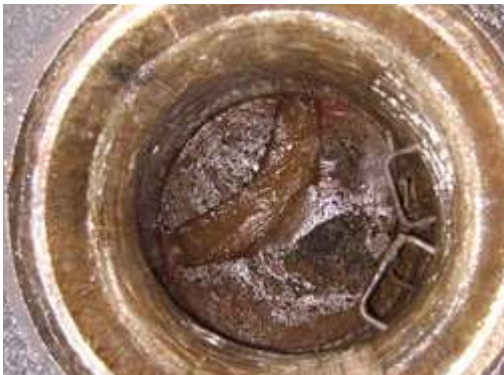
Defect 2

Condition: ☐ Sound ☐ Cracked ☐ Root Intrusion ☐ Loose Brick ☒ **Deteriorated**

Infiltration: ☐ None ☐ Joint ☐ Cracks ☒ **Mortar** ☐ Roots ☒ **Wall**

Condition: ☐ Sound ☐ Cracked ☐ Root Intrusion ☐ Deteriorated ☐ Leaks ☒ **Debris**

Debris on bench from barrel wall infiltration.

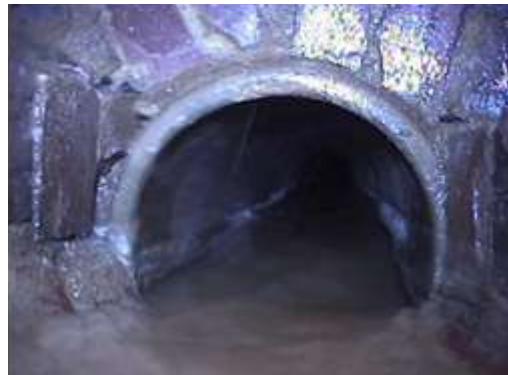
Defect 1

cracked pipe seal 9:00-2:00 incoming 9 o'clock

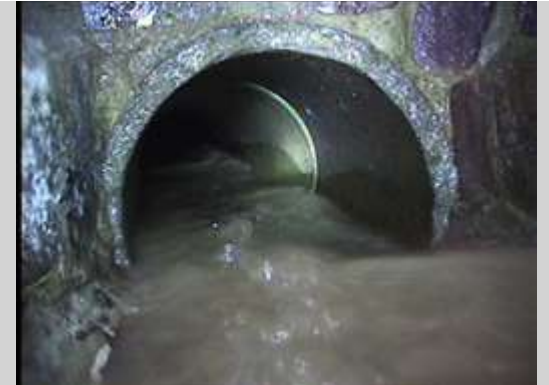
12 O'Clock Outflow

8 in. Circular Gravity Sewer  
Pipe Out @ 12 O'Clock

Pipe Height: **8.4** (in.) Rod and Bar (Angled)  
Pipe Material: **Clay** ☒ Pipe Lined  
Invert Depth: **10.17** (ft.) Flow Characteristics: **Fast**  
Deposits: ☒ None ☐ Mud ☐ Sludge ☐ Debris ☐ Grease  
Silt Depth: (in.) Deposits Extent:  
Infiltration: **None** Pipe Seal Cond: **Sound**

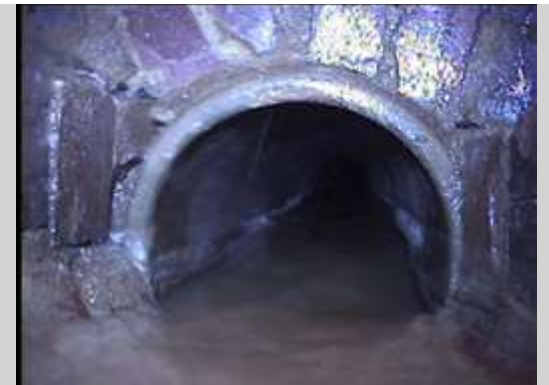
9 O'Clock Inflow

8 in. Circular Gravity Sewer  
Pipe In @ 9 O'Clock

Pipe Height: **8.4** (in.) Rod and Bar (Angled)  
Pipe Material: **Clay** ☐ Pipe Lined  
Invert Depth: **10.17** (ft.) Flow Characteristics: **Fast**  
Deposits: ☒ None ☐ Mud ☐ Sludge ☐ Debris ☐ Grease  
Silt Depth: (in.) Deposits Extent:  
Infiltration: **None** Pipe Seal Cond: **Cracked**
